ANALYSIS OF EXHAUST VOLUME REDUCTION IN *OILY WATER SEPARATOR* AT SS. GOLDEN ISAIA

^{1,2,3} Semarang Maritime Polytechnic

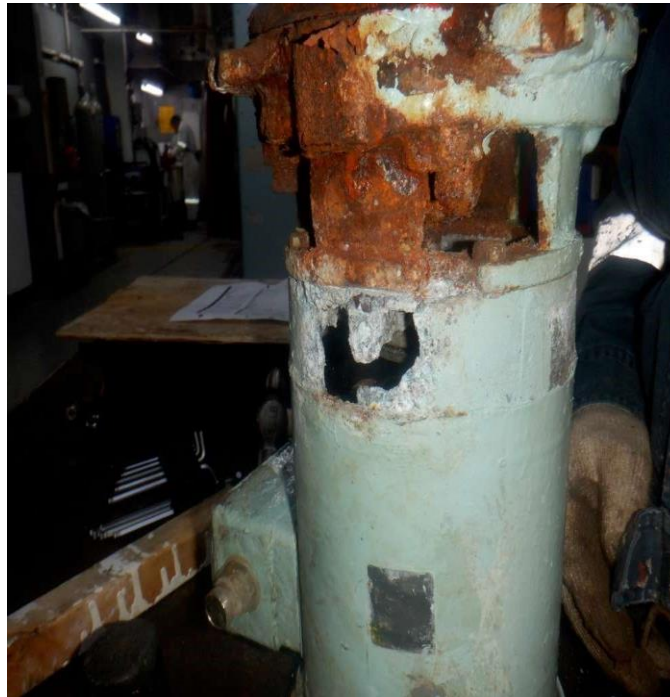
Based on data from observation results, it has been found that the engine factor causes a decrease in exhaust volume in the oily water separator in SS. GOLDEN ISAIA is in the feed pump, the feed pump is a component of the oily water separator that sucks sewage water from the bilge tank through the HELI-SEP Separator tube and then presses it toward the filter. The pressure of this pump is one of the main causes of a decrease in exhaust volume in the oily water separator showed in Figure 3, when conducting observations during the operation of OWS it was found that the feed pump pressure was less than the normal working pressure according to the manual book.

Figure 3 Condition of the feed pump oily water separator
Source: Research Documentation

After a visual check, it was found that the physical condition of the pump had been eaten away by corrosion, and when the pump was opened the impeller condition had also been eaten away by corrosion and was very difficult to remove from its shaft, as well as its bearing. This caused the feed pump pressure to be low and not operating at the working pressure according to the manual.

Corrosion on the feed pump can be caused by high humidity in the air around the oily water separator. If this is left unchecked, corrosion will spread further to the oily water separator components.

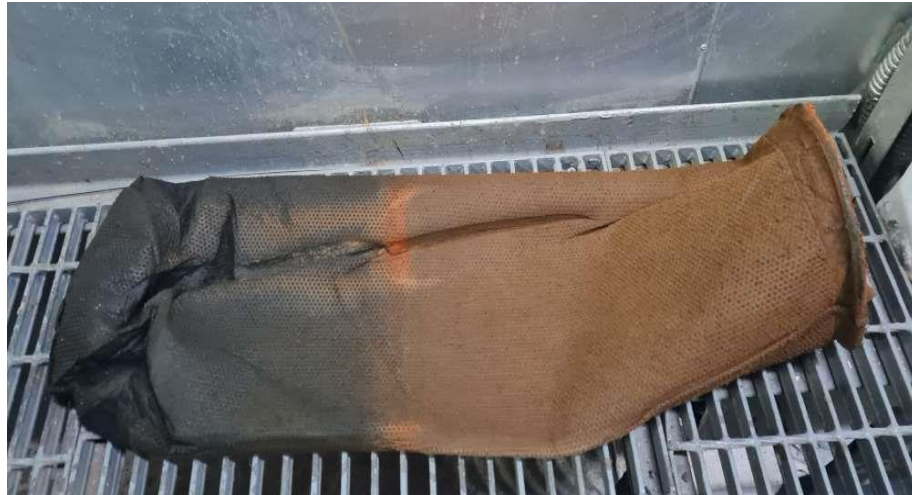
Material factors that cause a decrease in exhaust volume in OWS at SS. Golden Isaia are coarse particles in the bilge tank causing the OWS process filter to become increasingly clogged. Dirty process filters can also be one of the findings that cause a decrease in exhaust volume in the oily water separator. This can be indicated by the differential pressure gauge indicator which shows the difference in pressure before and after passing through the process filter. According to the manual book, the filter bag must be replaced when the pressure reaches 1 bar. When observed, the differential pressure had reached 1.2 bar showed in Figure 4.

Figure 4 Filter Bag in the oily water separator filter process
Source: Research Documentation

Dirty process filters in oily water separators can also affect the flow of water that will be discharged into the sea by oily water separators. A dirty process filter is caused by the accumulation of coarse particles from the bilge tank.

Based on data collected from observations, interviews, and literature studies, efforts to overcome the cause of dirt accumulation in the bilge tank process filter are to clean the strainer and replace the filter bag. This is done based on the manual book instructions (Ardhi et al., 2018). Inside the strainer of the process filter there is a filter bag as a double filter. The instructions in the manual book state that the filter bag must be replaced if the pressure differential before and after the process filter reaches a pressure of 1 bar showed in Figure 7

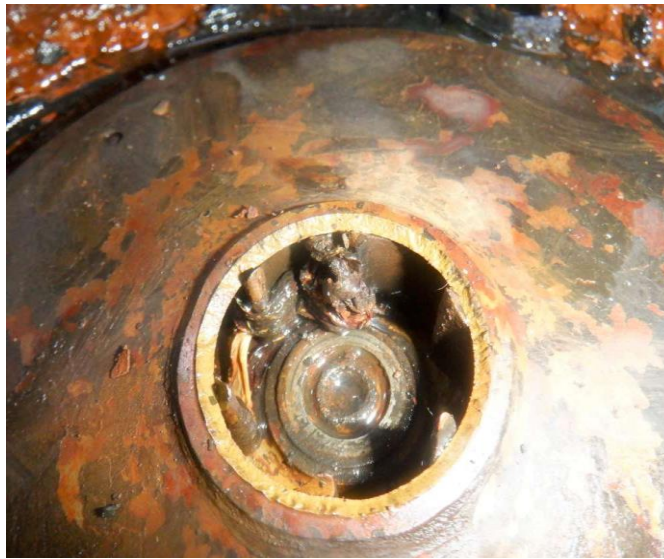
Figure 5 *feed pump* components affected by corrosion.
Source: Research Document

To handle the feed pump that has been corroded, initially the crew wanted to replace several pump components that were no longer feasible. However, this was not possible, because the components were stuck due to corrosion, and the pump casing was also mostly corroded. After checking the spare part room, a set of feed pump oily water separator along with its electric motor was available (Sulaiman & Suharto, 2020), so the effort to overcome the decrease in exhaust volume in the oily water separator at SS. Golden Isaia was to replace a set of OWS feed pump along with its electric motor showed in in Figure 6.

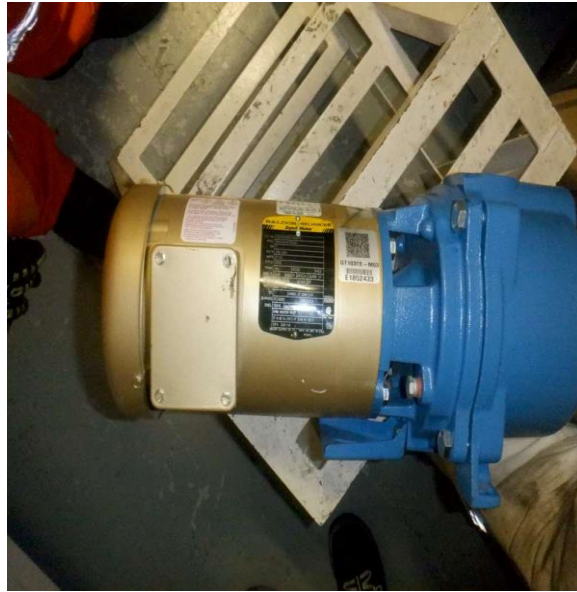
Figure 6 One set of OWS feed pumps
Source: Research Document

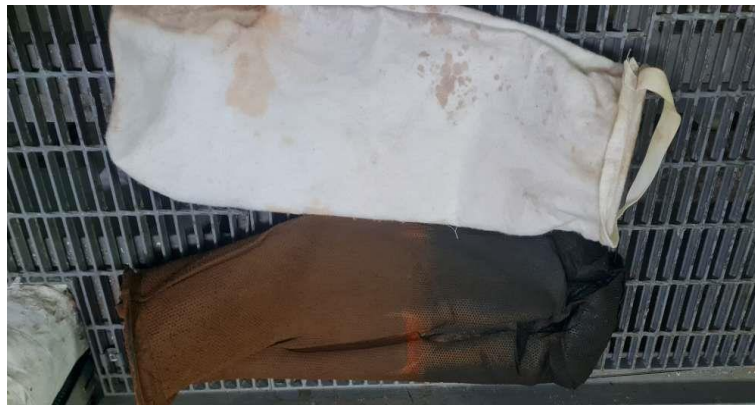
Figure 7. Replacement of OWS filter bag
Source: Research Document
