## ANALYSIS OF NOT ROTATING VALVE ROTATOR ON MAIN ENGINE PERFORMANCE IN KM. LABOBAR

<sup>1,2,3</sup> Politeknik Ilmu Pelayaran Semarang

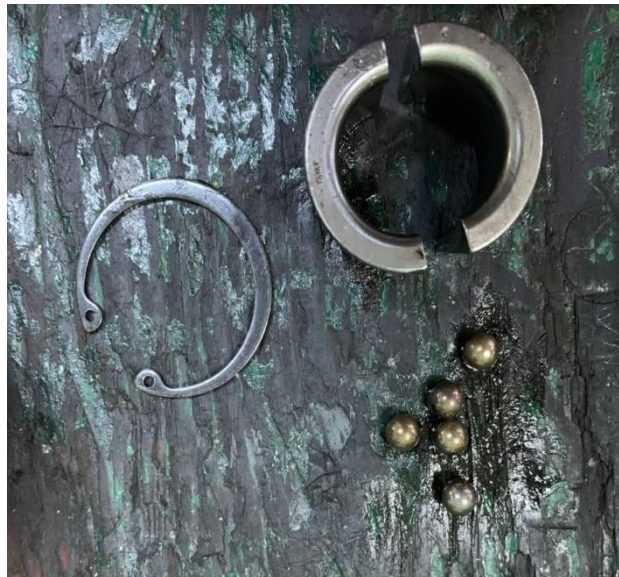
- a. Improper installation of collet valve (tiger nail) components

Figure 2. Collet valve Main Engine (Source: personal document)

Improper valve collet installation and valve rotator wear had a significant impact on engine performance. One of the cylinders experiences different exhaust gas temperature emissions, causing the valve to not function optimally.

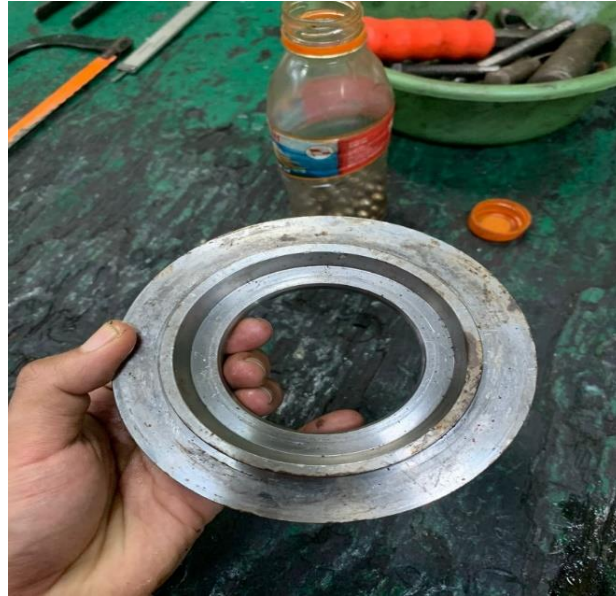
The cause of damage to the valve rotator on the main engine is due to wear on the body so that this can affect the performance of the valve rotator on the performance of the main engine, which is connected to the valve spring, valve bridge and rocker arm.

Figure 3. Valve rotator wear and tear  
Source: personal documents

The wear that occurs on the rotator valve body on the main engine causes the rotator valve on the main engine to not rotate. The pressure generated from the valve spring and rocker arm or valve bridge causes the rotator valve body to wear and results in the rotator valve not rotating. Poor lubrication of the rotator valve leads to increased exhaust emissions and faster wear of components, decreasing engine performance and causing leaks from the combustion chamber.

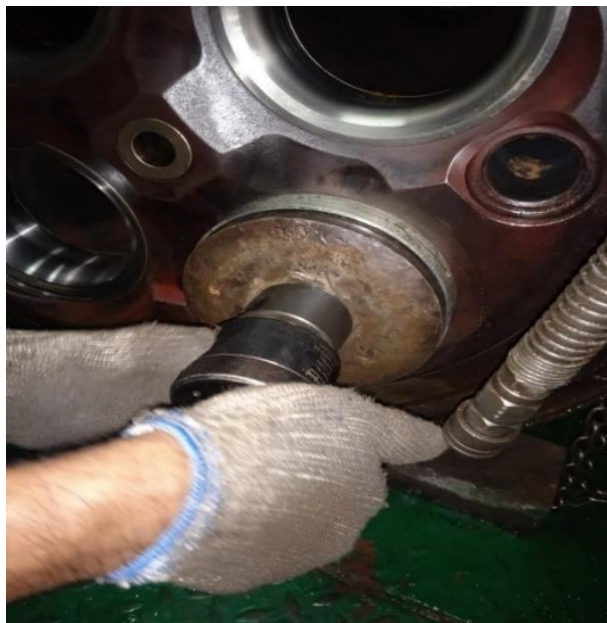
Lack of cooperation between crews contributed to the system failure. During duty, the lack of checks led to no maintenance action on the main engine rotator valve.

Figure 5. the lack of checks
